S-254
Davis Chapel
Rehobeth vicinity
public workshop

Maryland Historical Trust State Historic Sites Inventory Form

Survey No. S-254

historic Davis Chapel

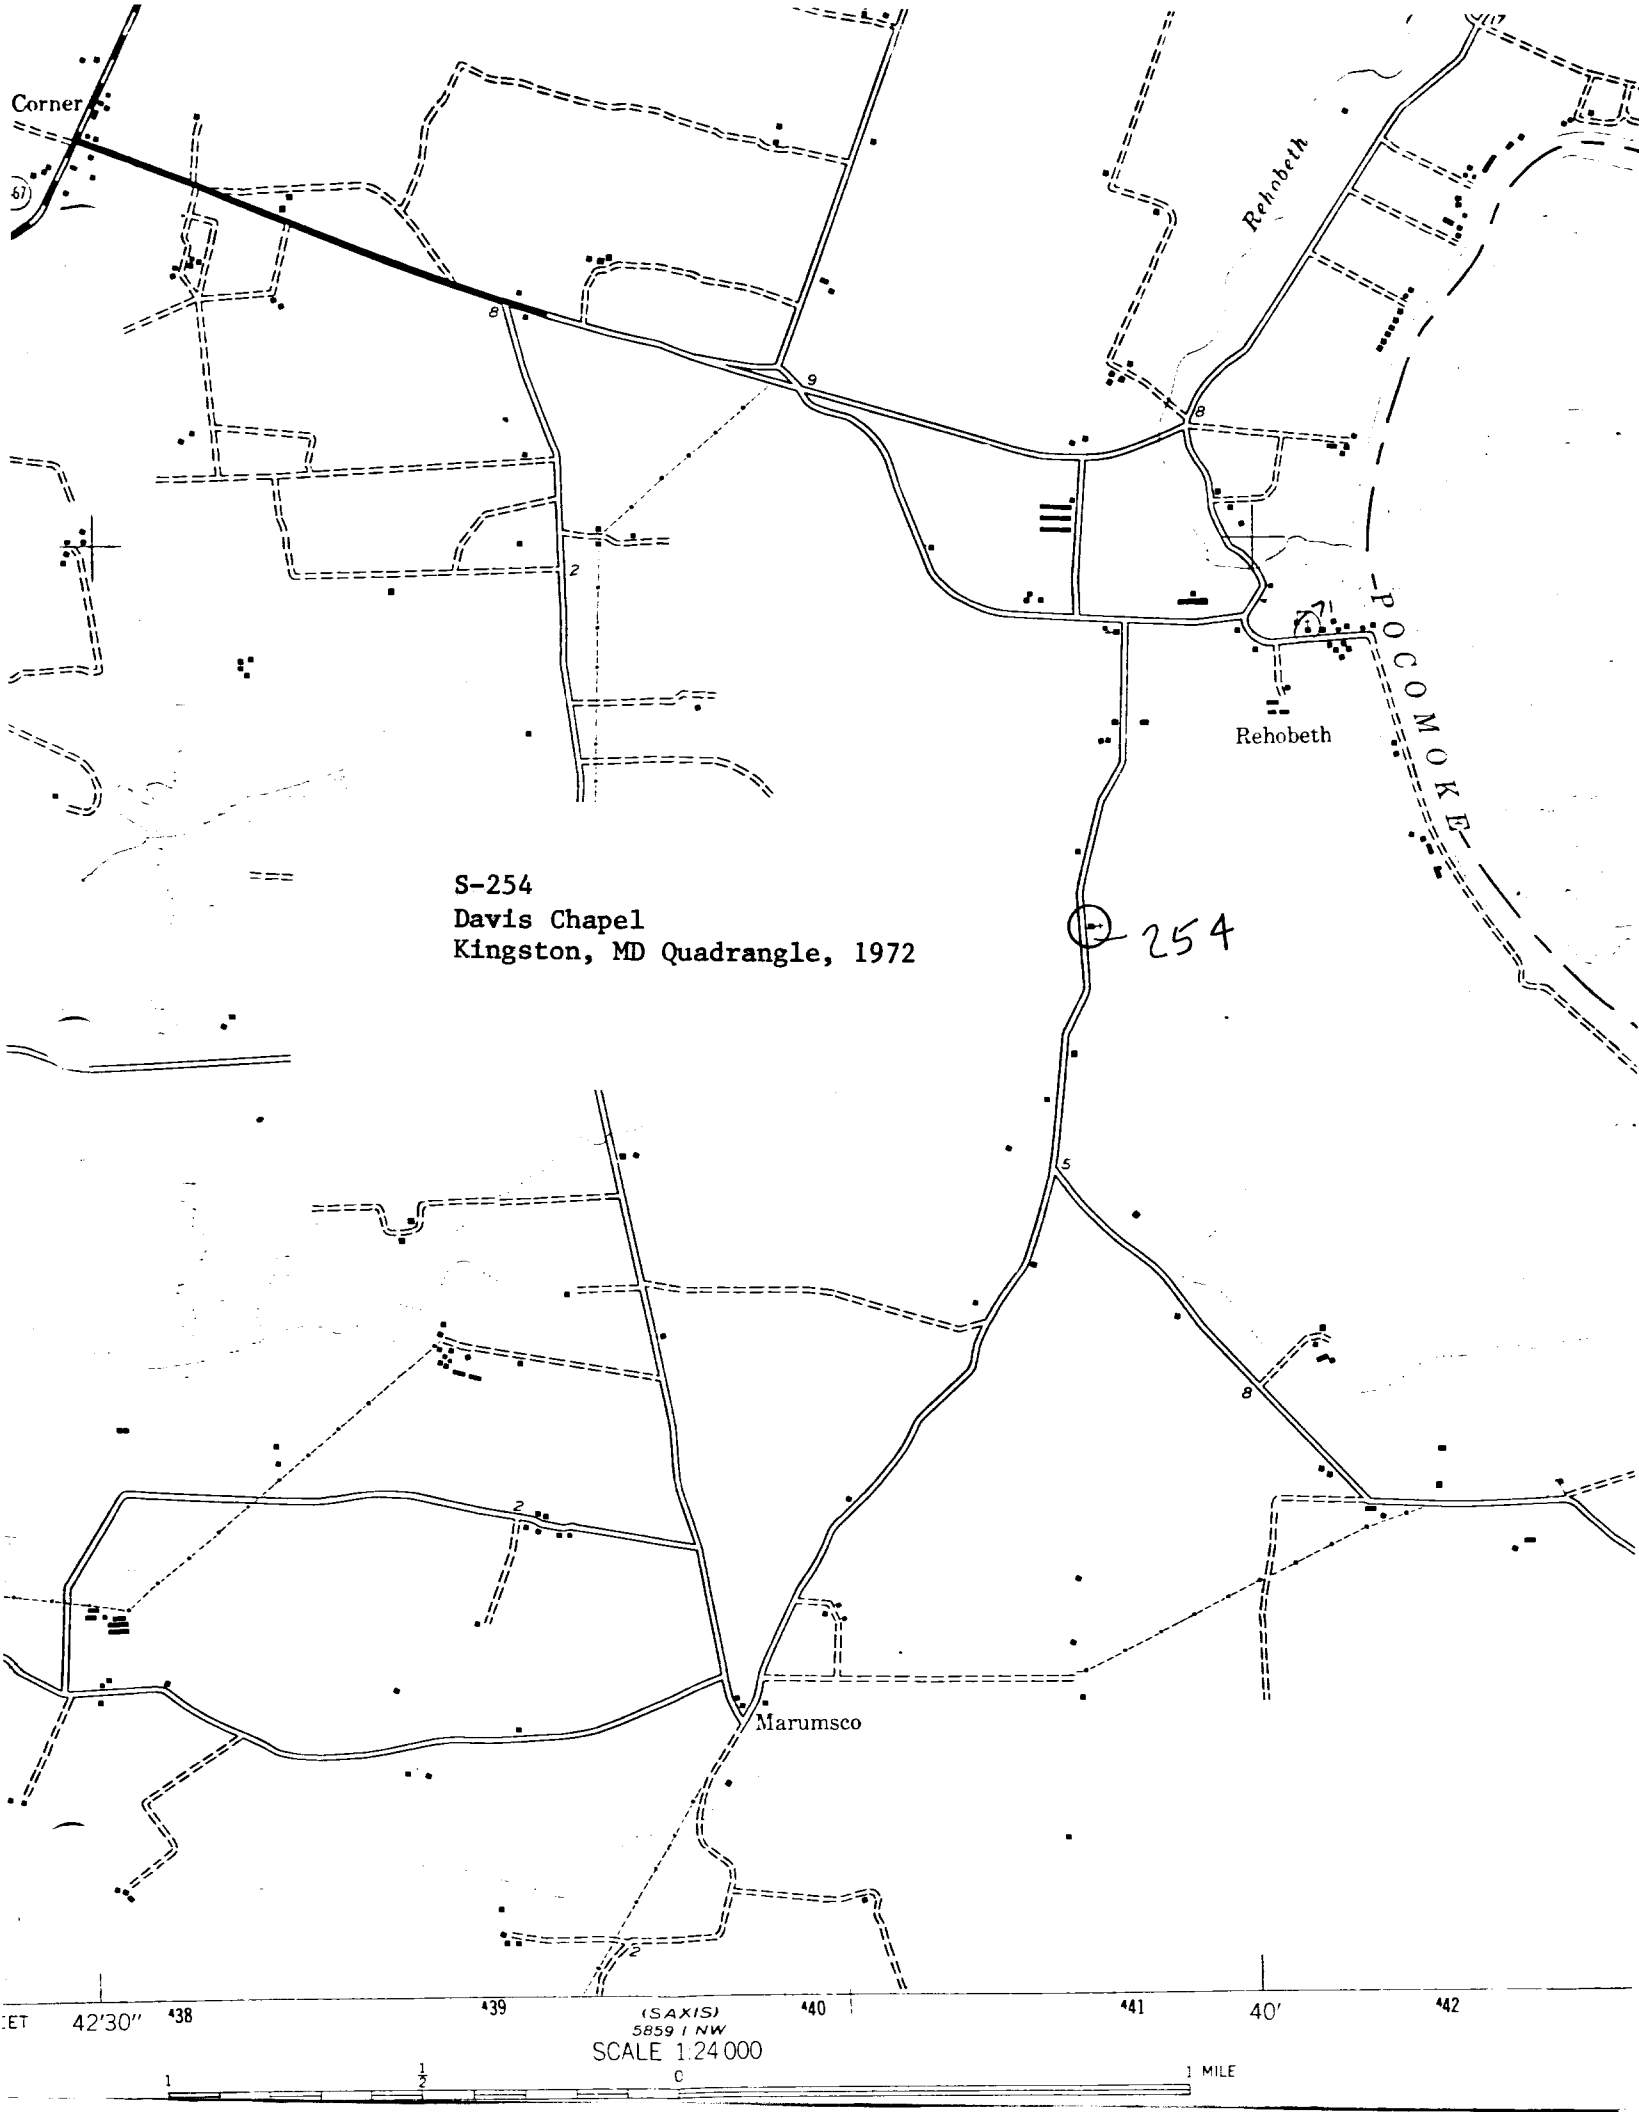
PS-2746

The west (main) elevation is largely covered by an off-center gabled entry vestibule reached by a flight of rusticated concrete block steps. The front newel posts have large concrete ball finials. A three over one sash pierces the foundation wall, while a single six over six sash window occupies the bay to the right of the entrance. Framing the front as well as the side elevations are plain pilasters. The wall space directly left of the entrance is filled with a large-size 9/6 sash window.

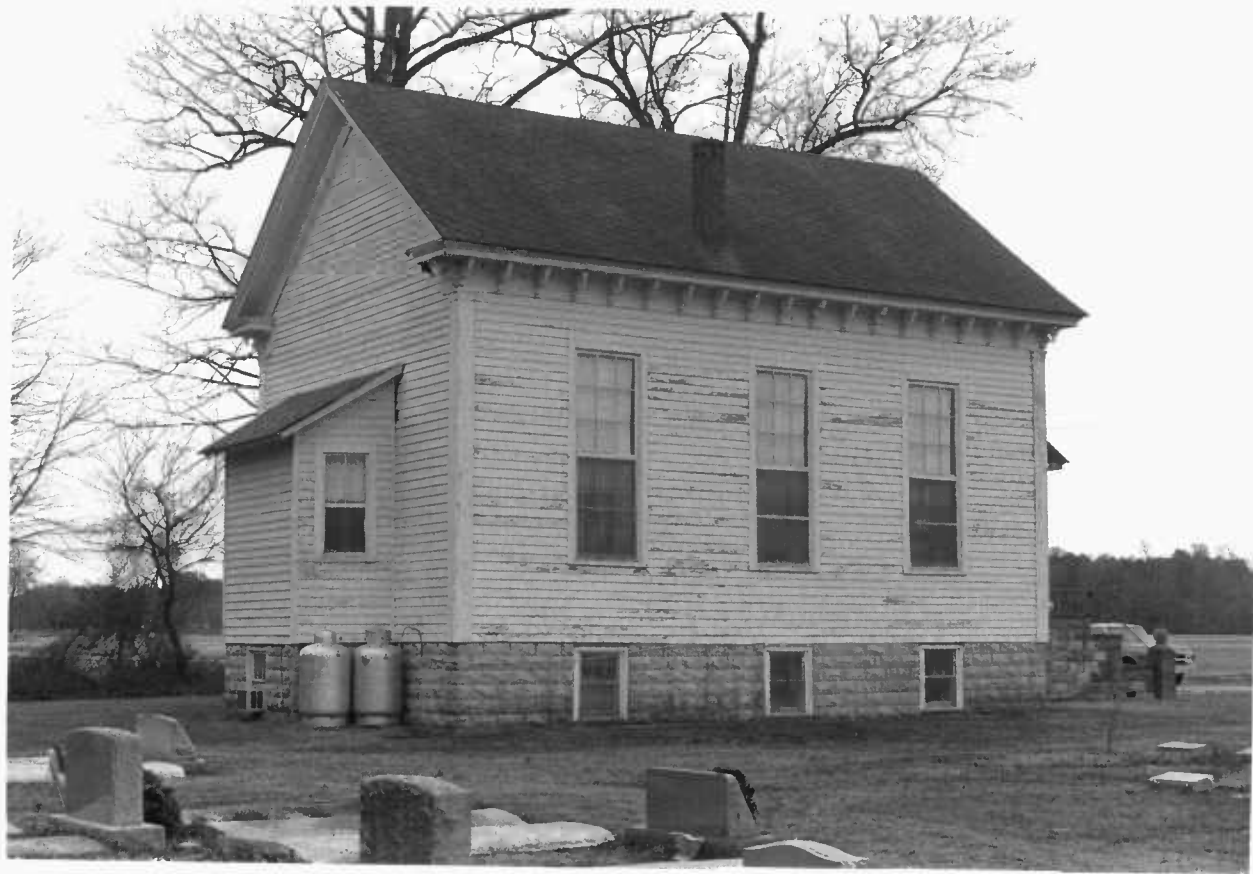
Davis Chapel S-254
Near Rehobeth, Somerset County
North Elevation
4/85, Photographer, Paul Touart
Neg./MD. Historical Trust

The north and south sides are essentially alike with 3/1 sash piercing the foundation wall, and three 9/6 sash lighting the sanctuary. A narrow stove stack rises from each side.

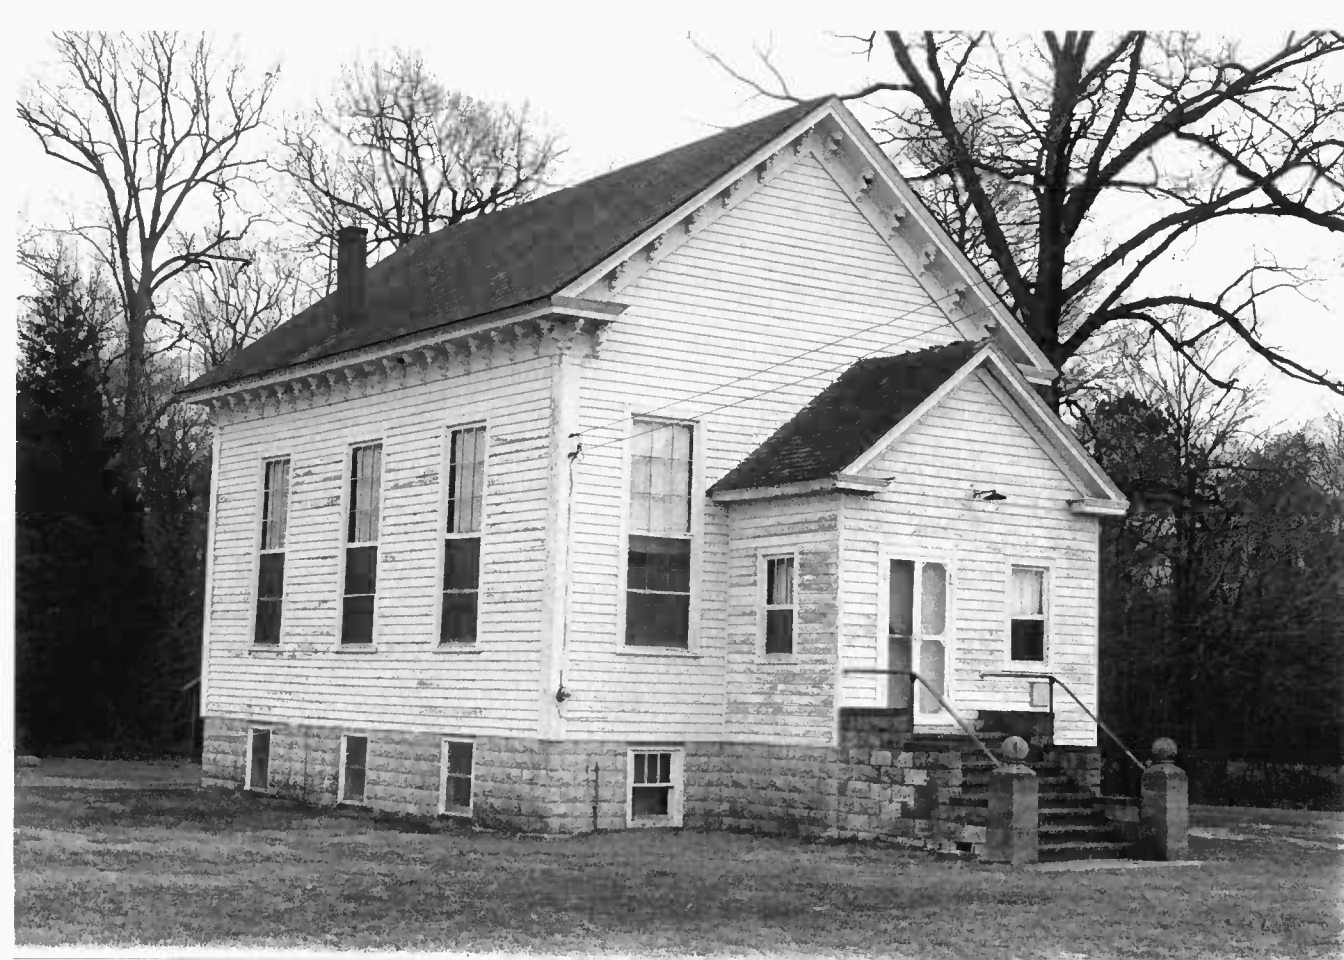
Davis Chapel S-254
Rehobeth vicinity, Somerset County, Md.
Northwest Elevation
3/85 Paul Touart, Photographer
Neg./Md. Hist. Trust

The dated 1876 rectangular frame structure is supported by a raised rusticated block foundation and is sheathed with uniform weatherboard siding. The medium sloped roof is covered with asphalt shingles, while the front and side eaves are embellished with decorative brackets.
